NASA TECHNICAL MEMORANDUM

NASA TM X-64846

MSFC SKYLAB ATM CALIBRATION
ROCKET PROJECT

Skylab Program Office

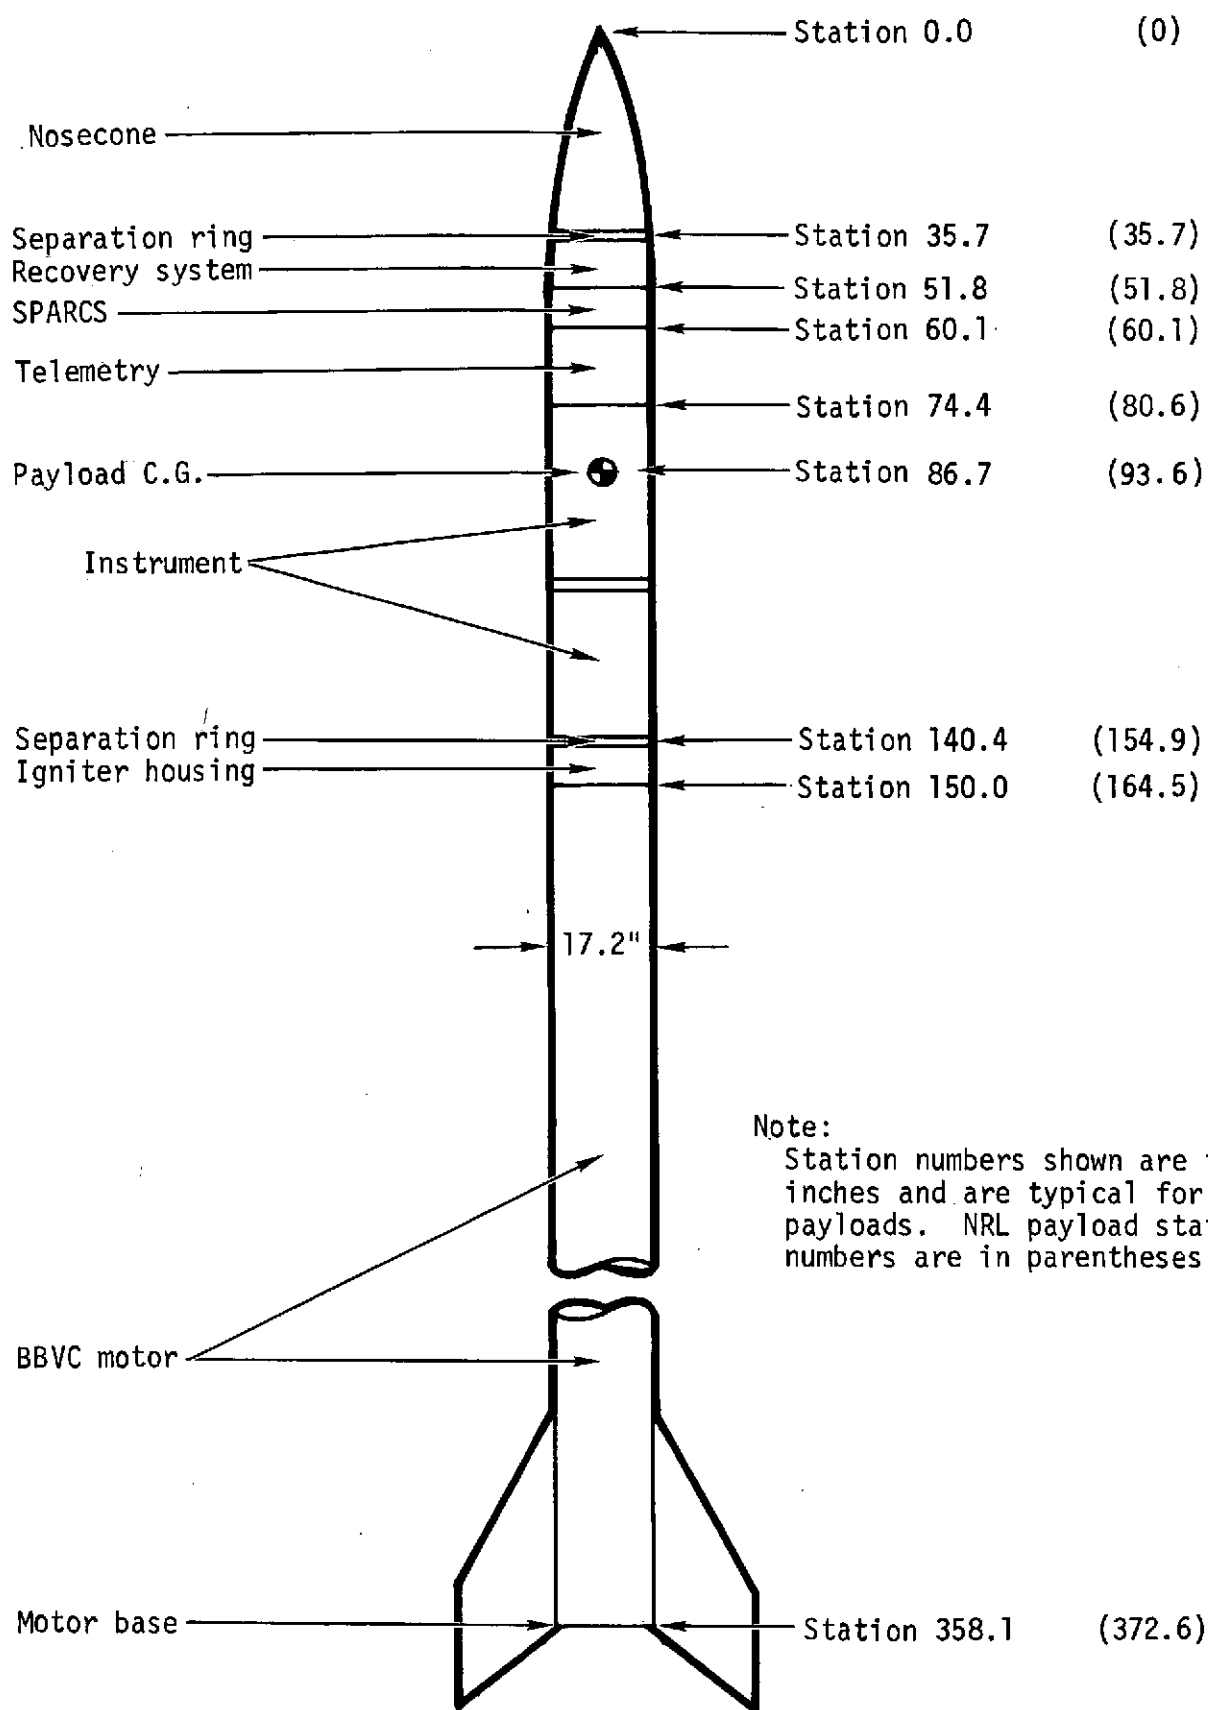
Figure 2-1. Skylab CALROC Payload/Booster Motor Configuration

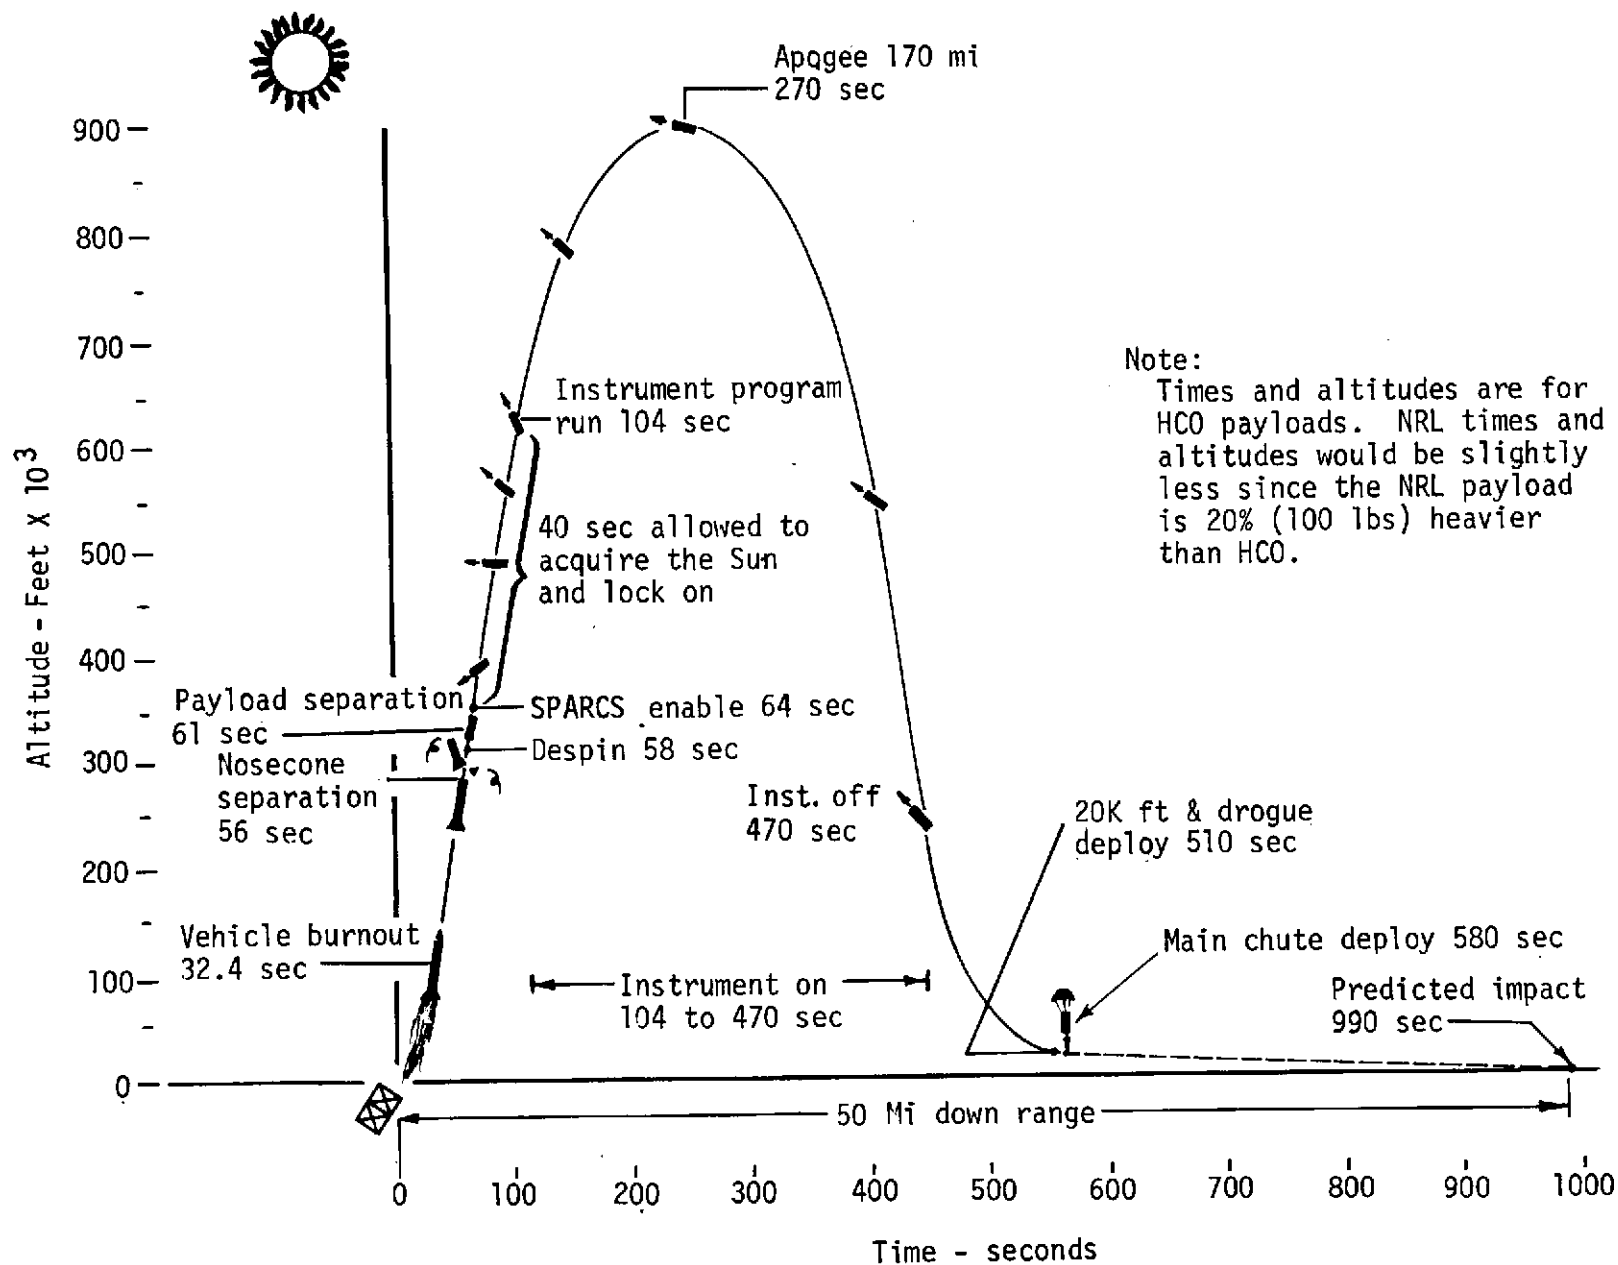
Figure 2-2. Typical Skylab CALROC Flight Profile

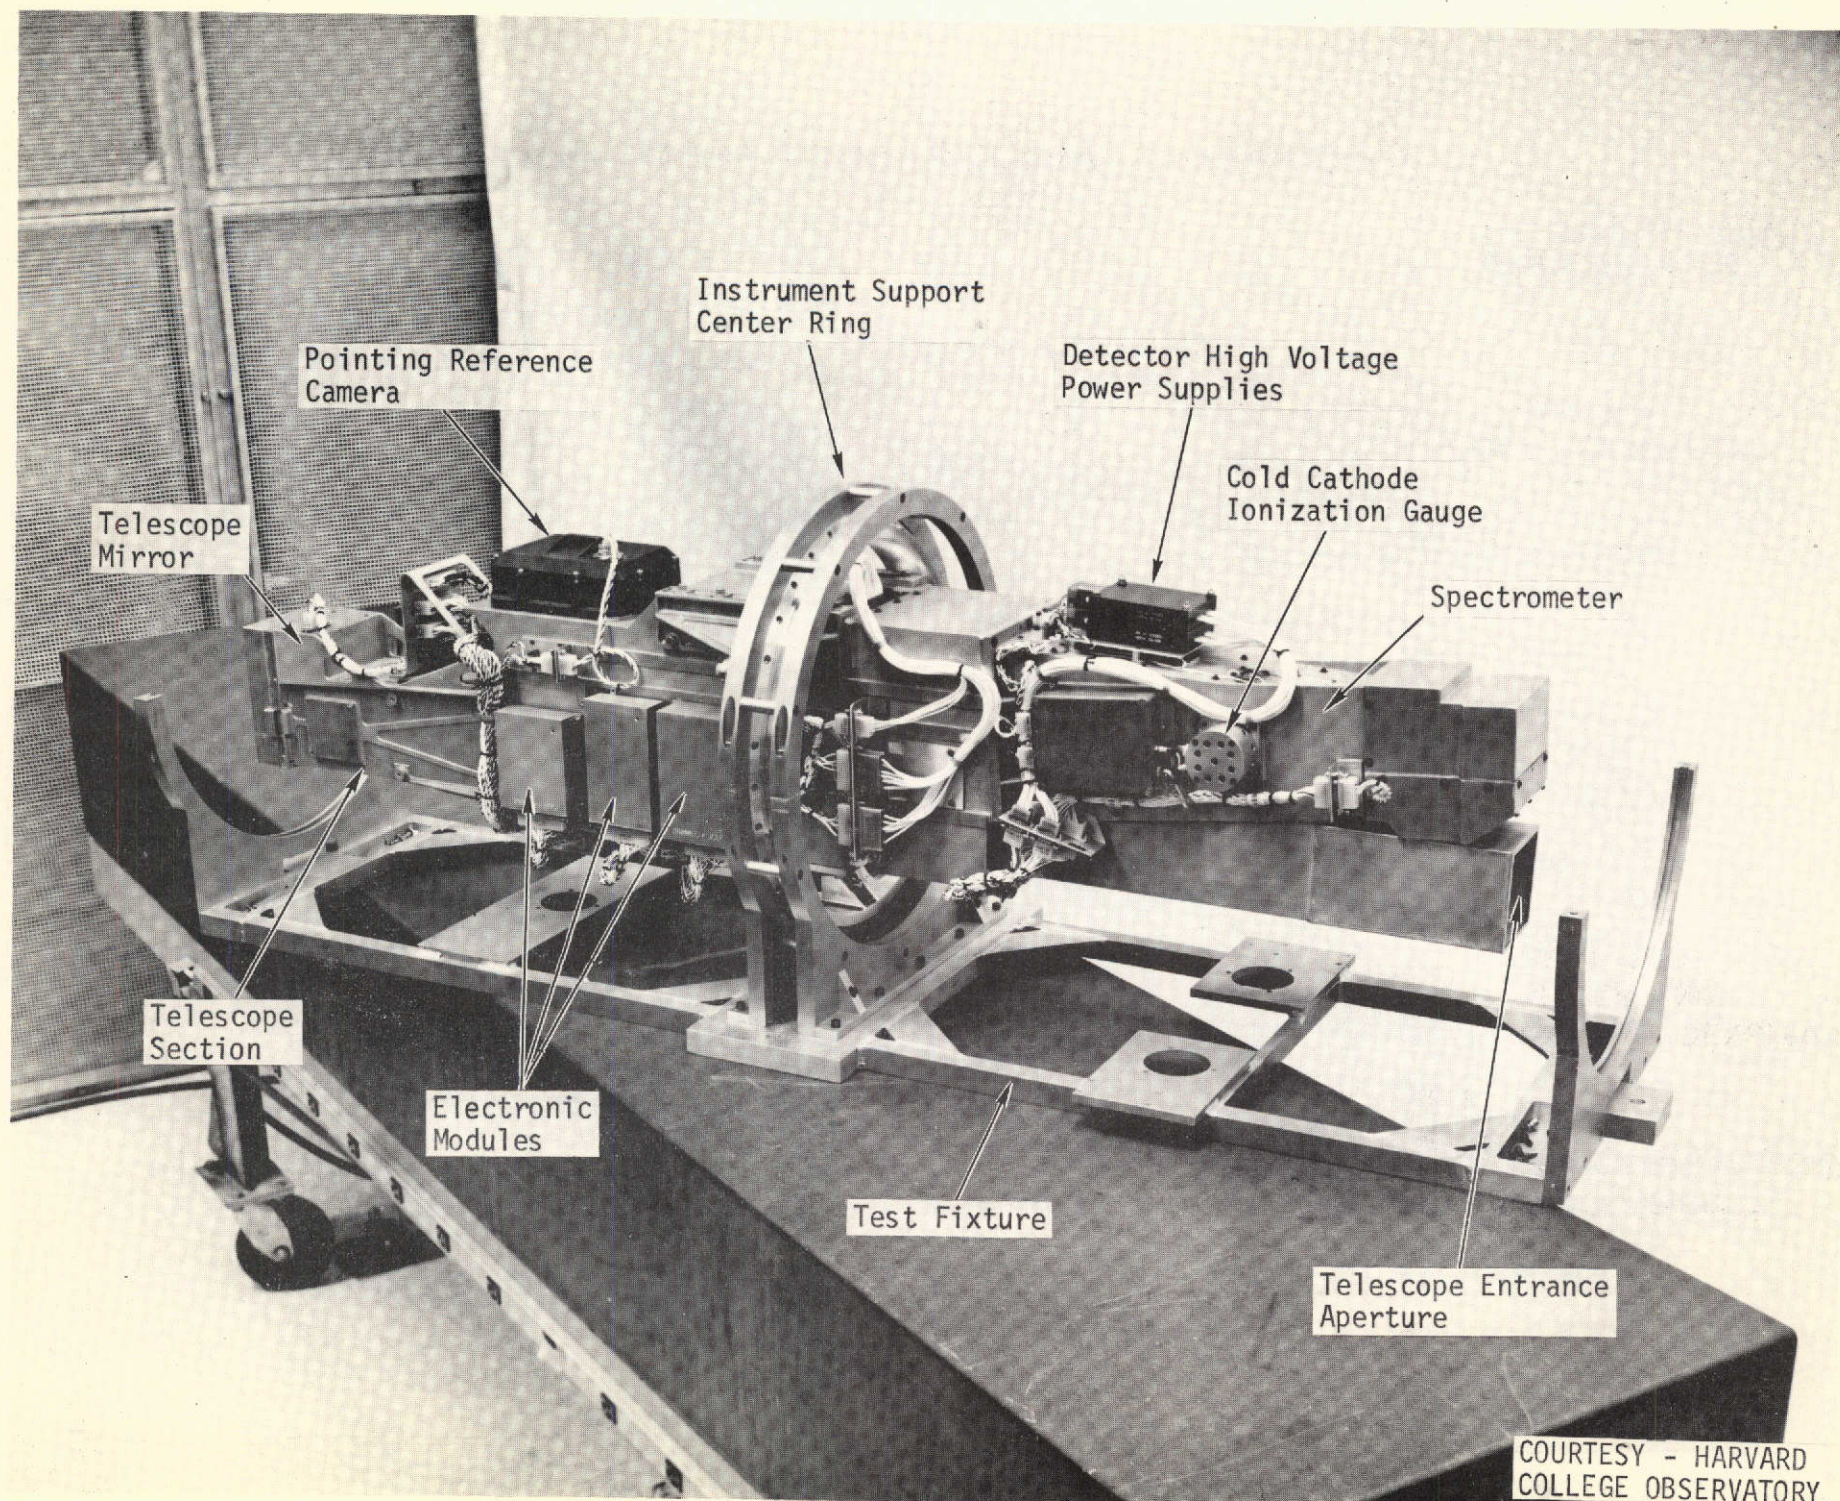
2.2.2 HCO Scientific Instrument. The HCO Scientific Instrument, shown in Figure 2-5, was an extreme ultraviolet (EUV) spectroheliometer designed to monitor solar radiation in the wavelength range 1350 Å to 300 Å with a 1.6 Å spectral resolution.⁷ The spectroheliometer consisted of three main subsystems; a telescope, spectrometer and pointing reference camera.

Figure 2-5. HCO CALROC Scientific Instrument

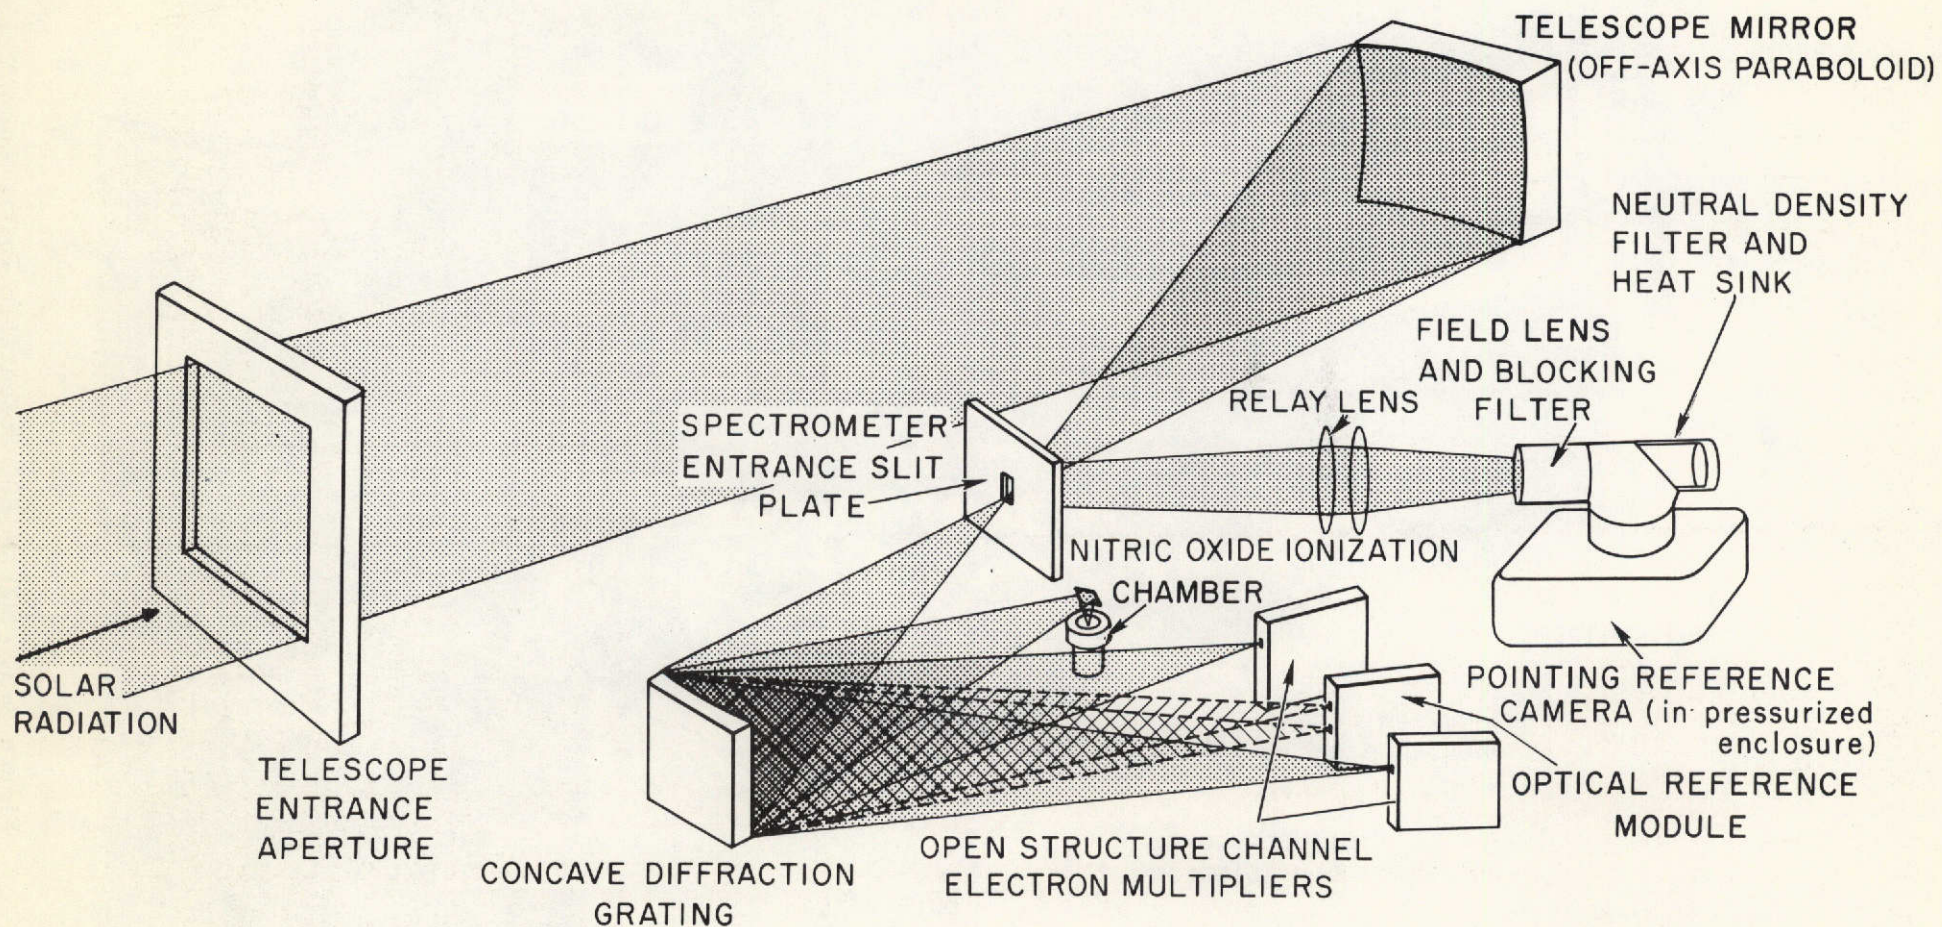
Figure 2-6. Optical Schematic of the HCO CALROC Spectroheliometer

The entrance slit had dimensions of 80 microns by 1040 microns, corresponding to an angular field of view of 20 arc sec by 4 arc min. The exit slits were 143 microns wide by 3 mm in length. All the slits were produced by electron-discharge machining, the slit plates being manufactured from thin stainless steel. Photoelectric detectors employed in the spectrometer were two-stage channel electron multipliers requiring an operating vacuum of 1×10^{-5} torr. A special vacuum pumping system (shown in Figure 2-8 attached to one of the HCO CALROC payloads) was designed and built for ground test and launch preparation of the HCO Scientific Instruments.

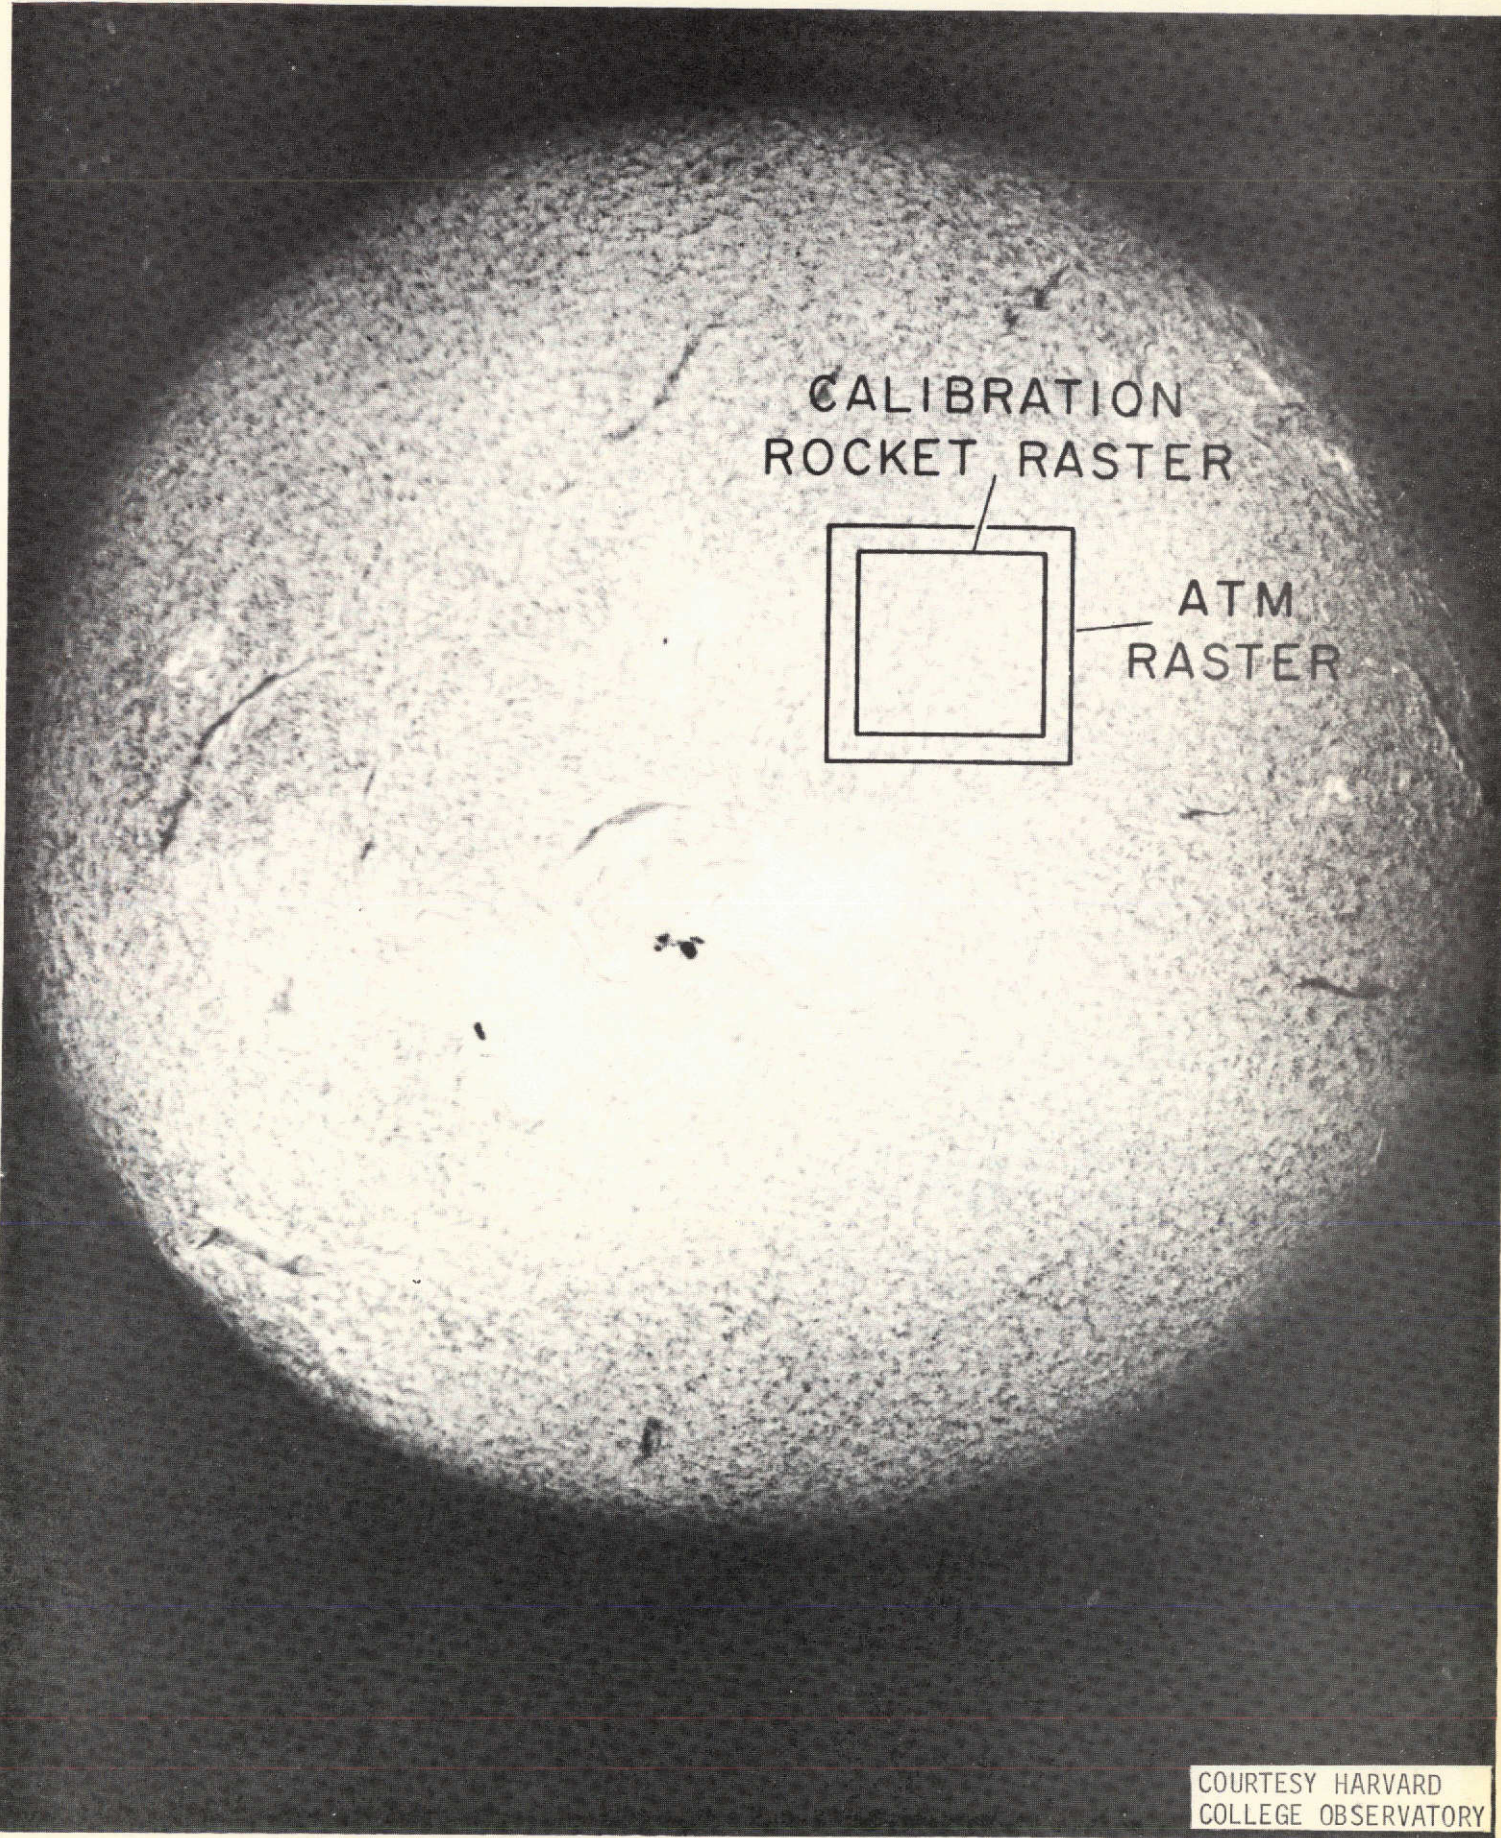
Figure 2-7. Areas of the Solar Disc Monitored by the ATM and HCO CALROC Spectroheliometers.

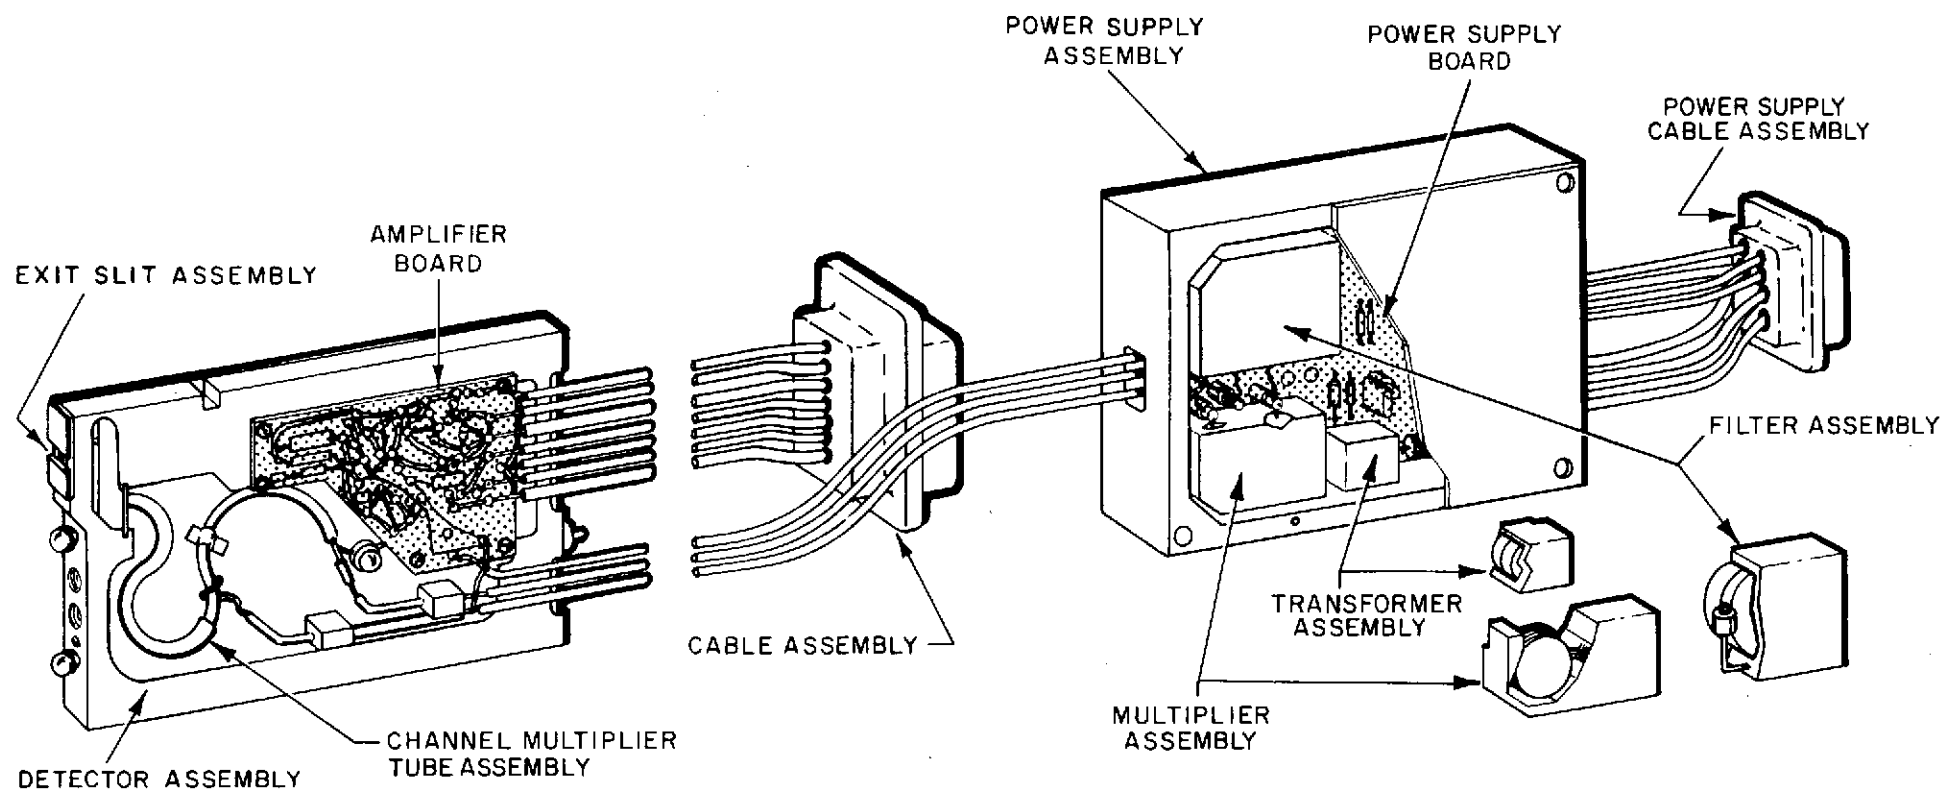
Figure 2-9. HCO CALROC Channel Electron Multiplier Detector Unit

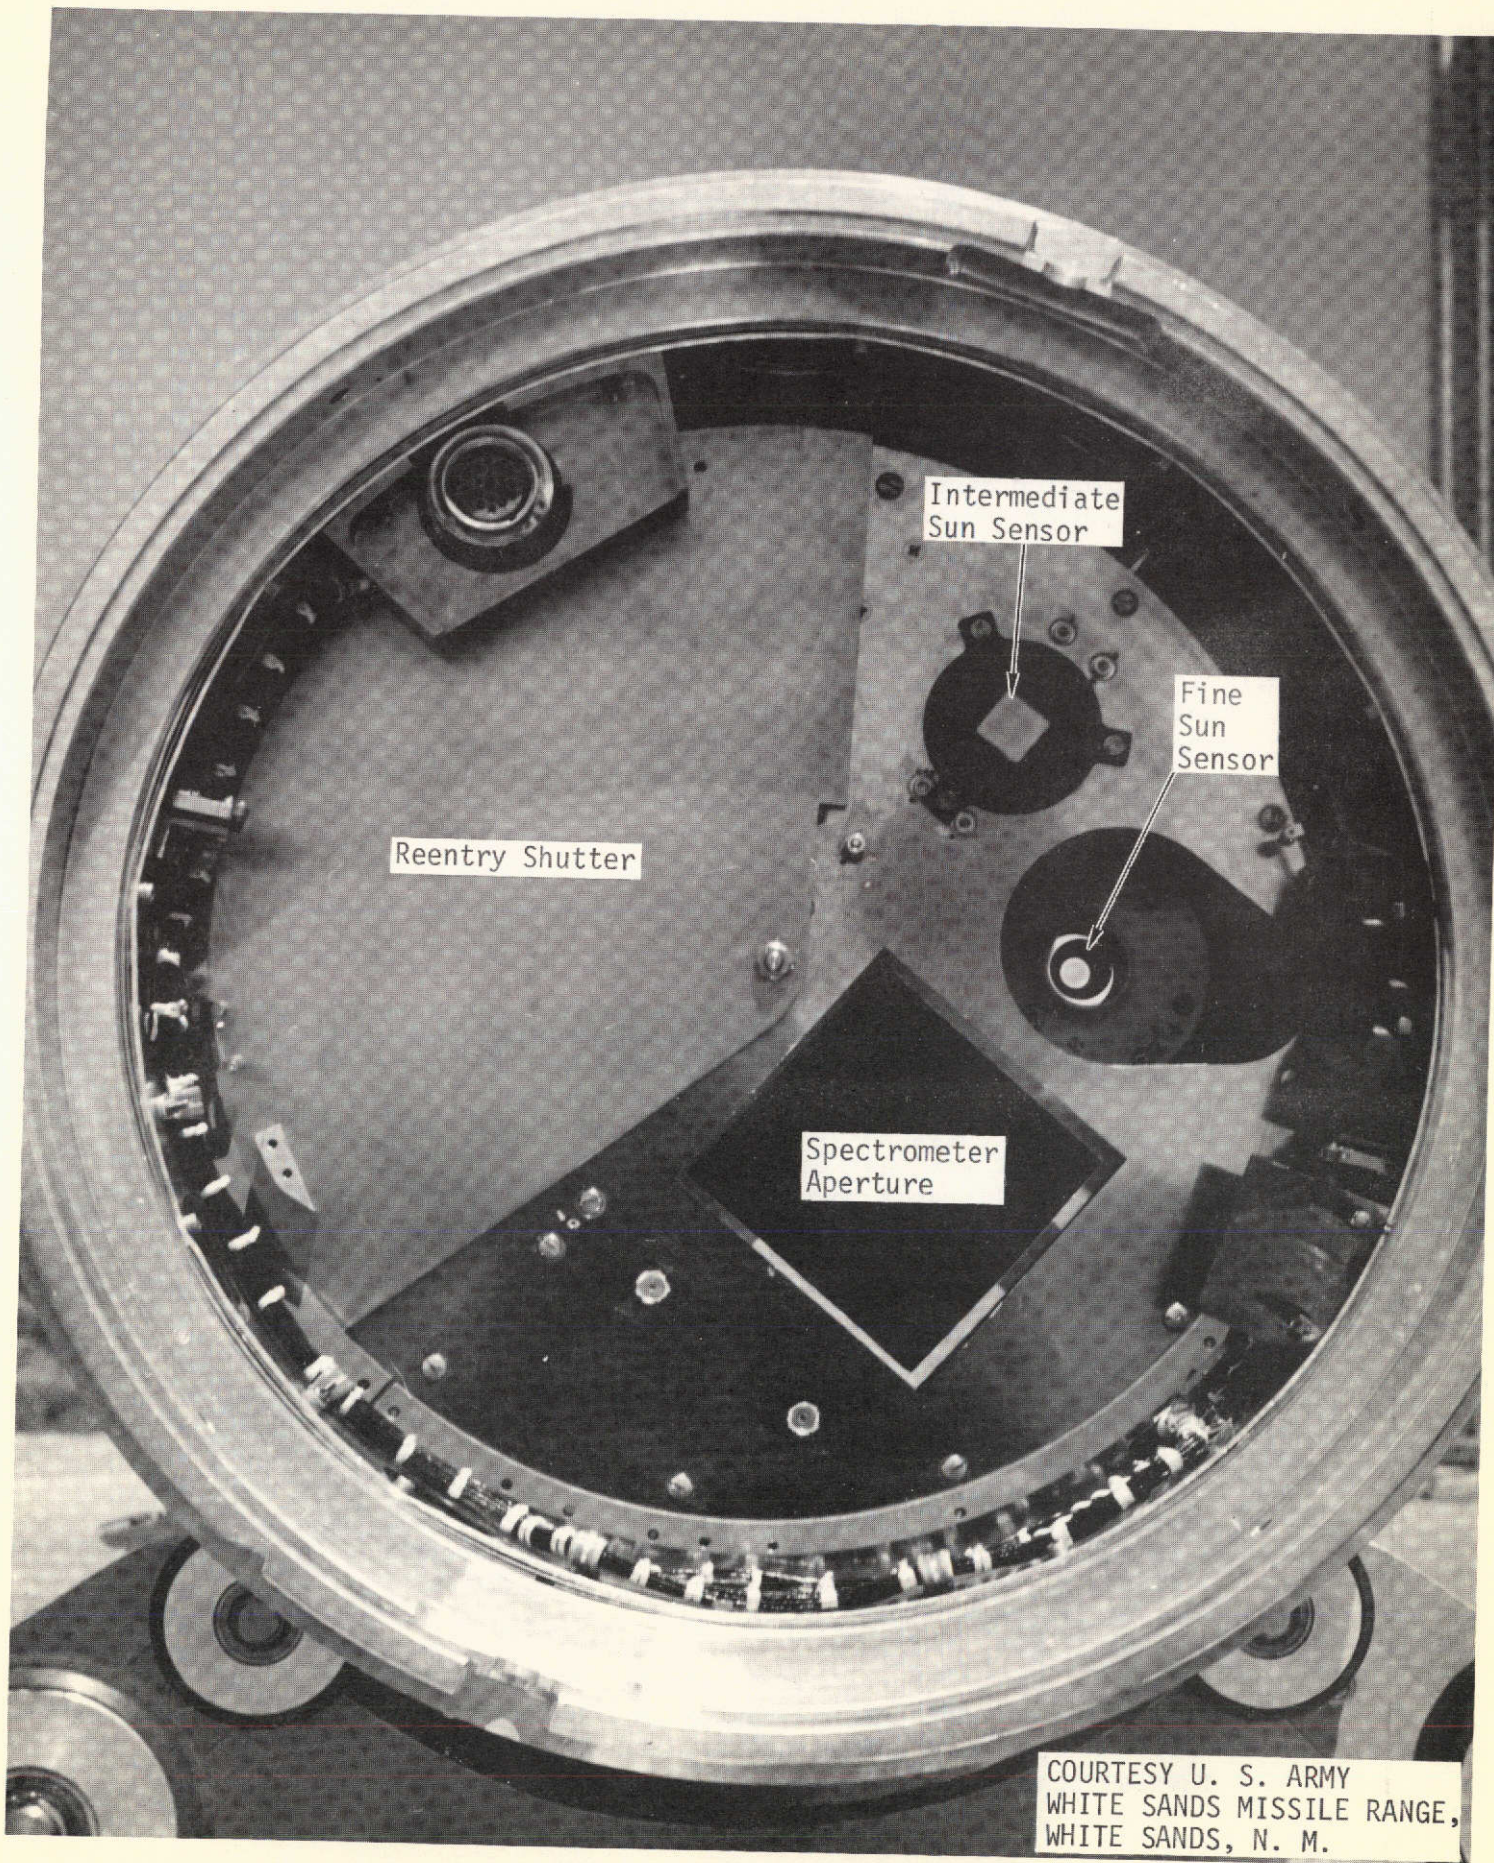
Figure 2-16. HCO CALROC Intermediate and Fine Sun Sensors

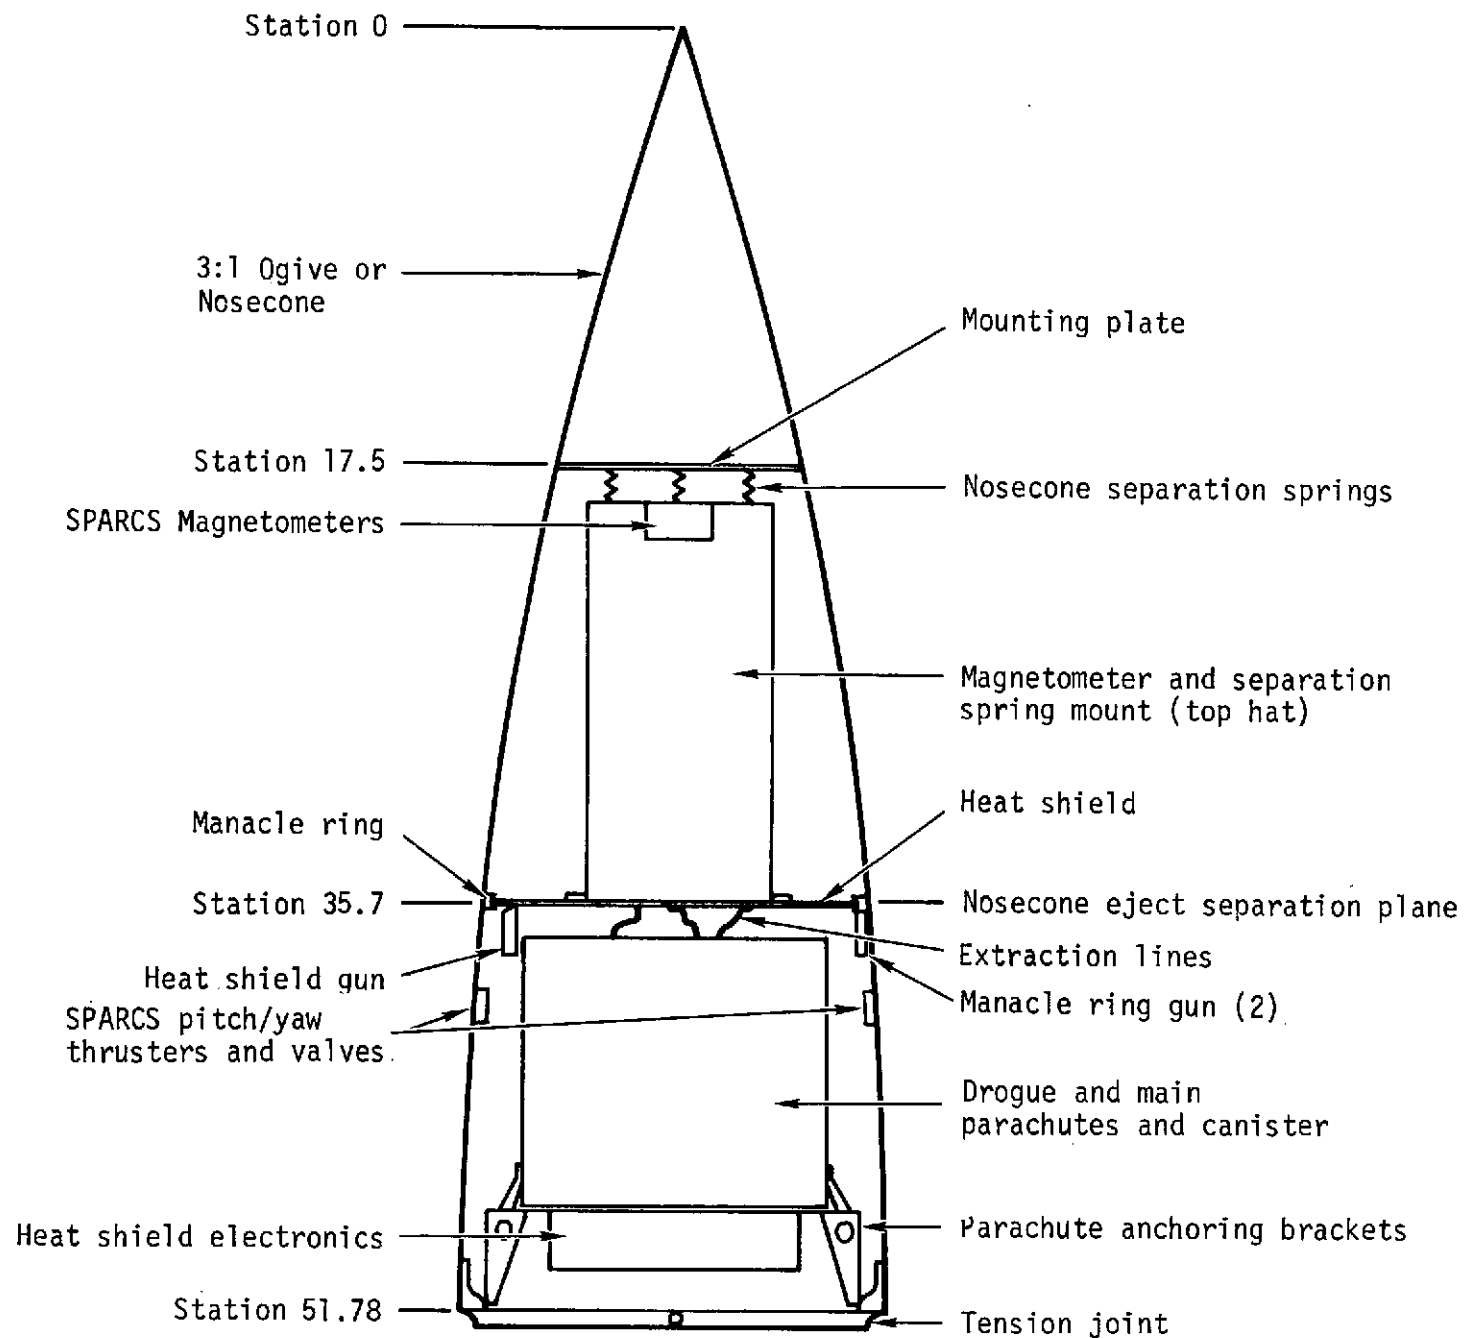
Figure 2-18. CALROC Nosecone and Recovery System

2.2.8 Separation Systems. Two separation systems were used on all CALROC payloads: one to separate the payload from the Rocket Motor and Igniter Housing after Motor burnout and a second one to remove the Nosecone during flight. Both separation systems employ manacle rings of the type shown in Figure 2-21. The Nosecone Separation system used three springs in sufficient compression to impart an adequate delta velocity to the Nosecone during separation to prevent any inflight collision. At Nosecone separation the vehicle was separated into four distinct parts; Nosecone, manacle rings and payload/motor combination. The payload separation system used four springs, shown in Figure 2-22, mounted on the Igniter Housing and compressed to provide a separation velocity between payload and rocket motor of 2 feet/second. At payload separation the existing vehicle was separated into four distinct parts; controlled payload, manacle rings and Igniter Housing Motor combination. Activation and timing of both separations were controlled by redundant mechanical timers in the Instrumentation and Telemetry system.

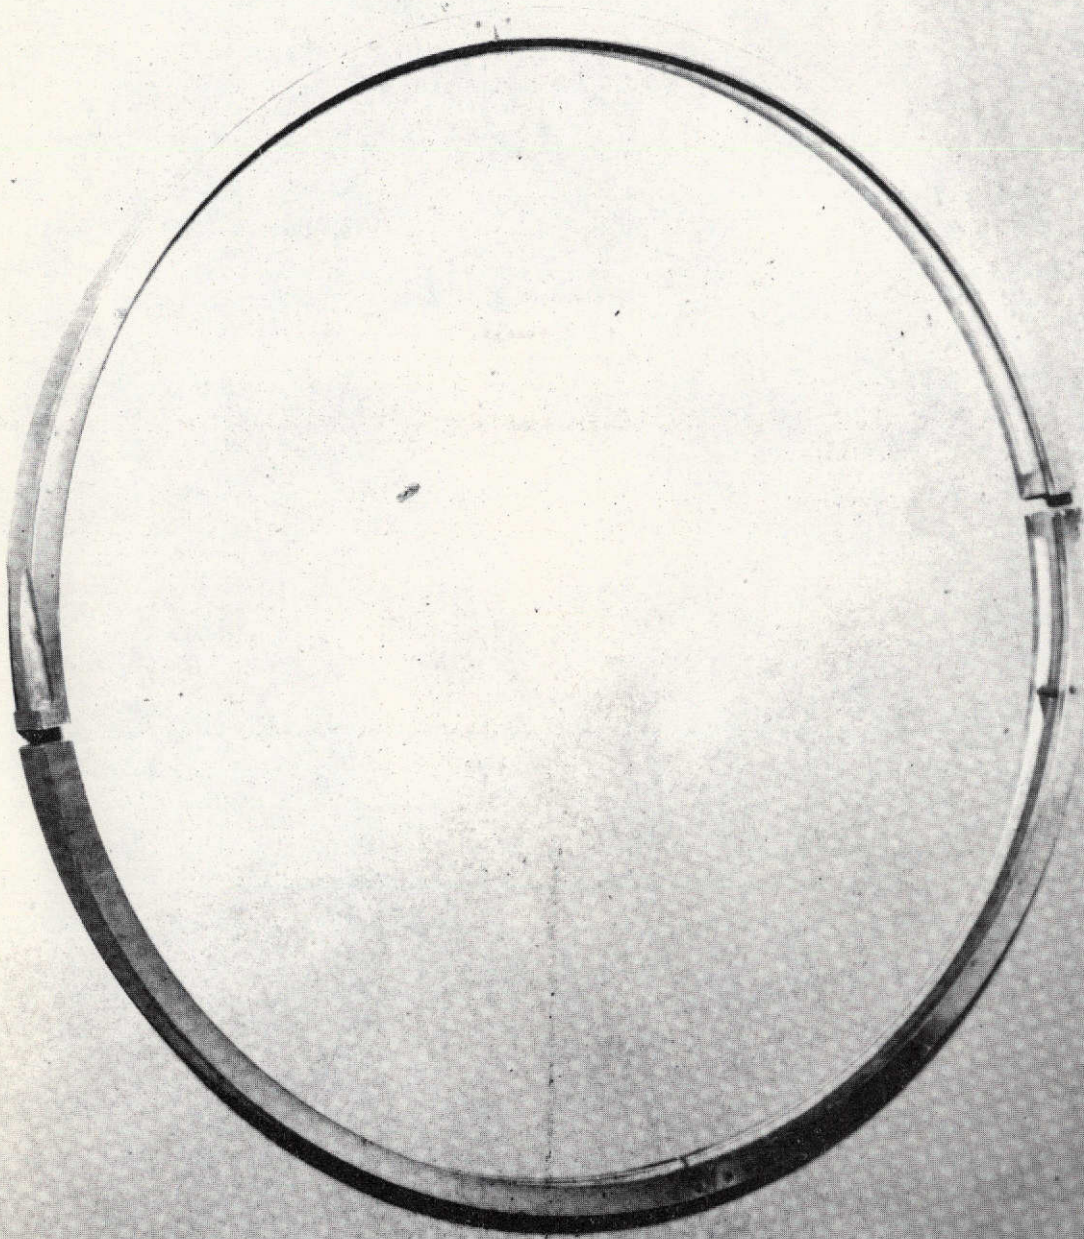
Figure 2-21. Typical CALROC Manacle Ring.

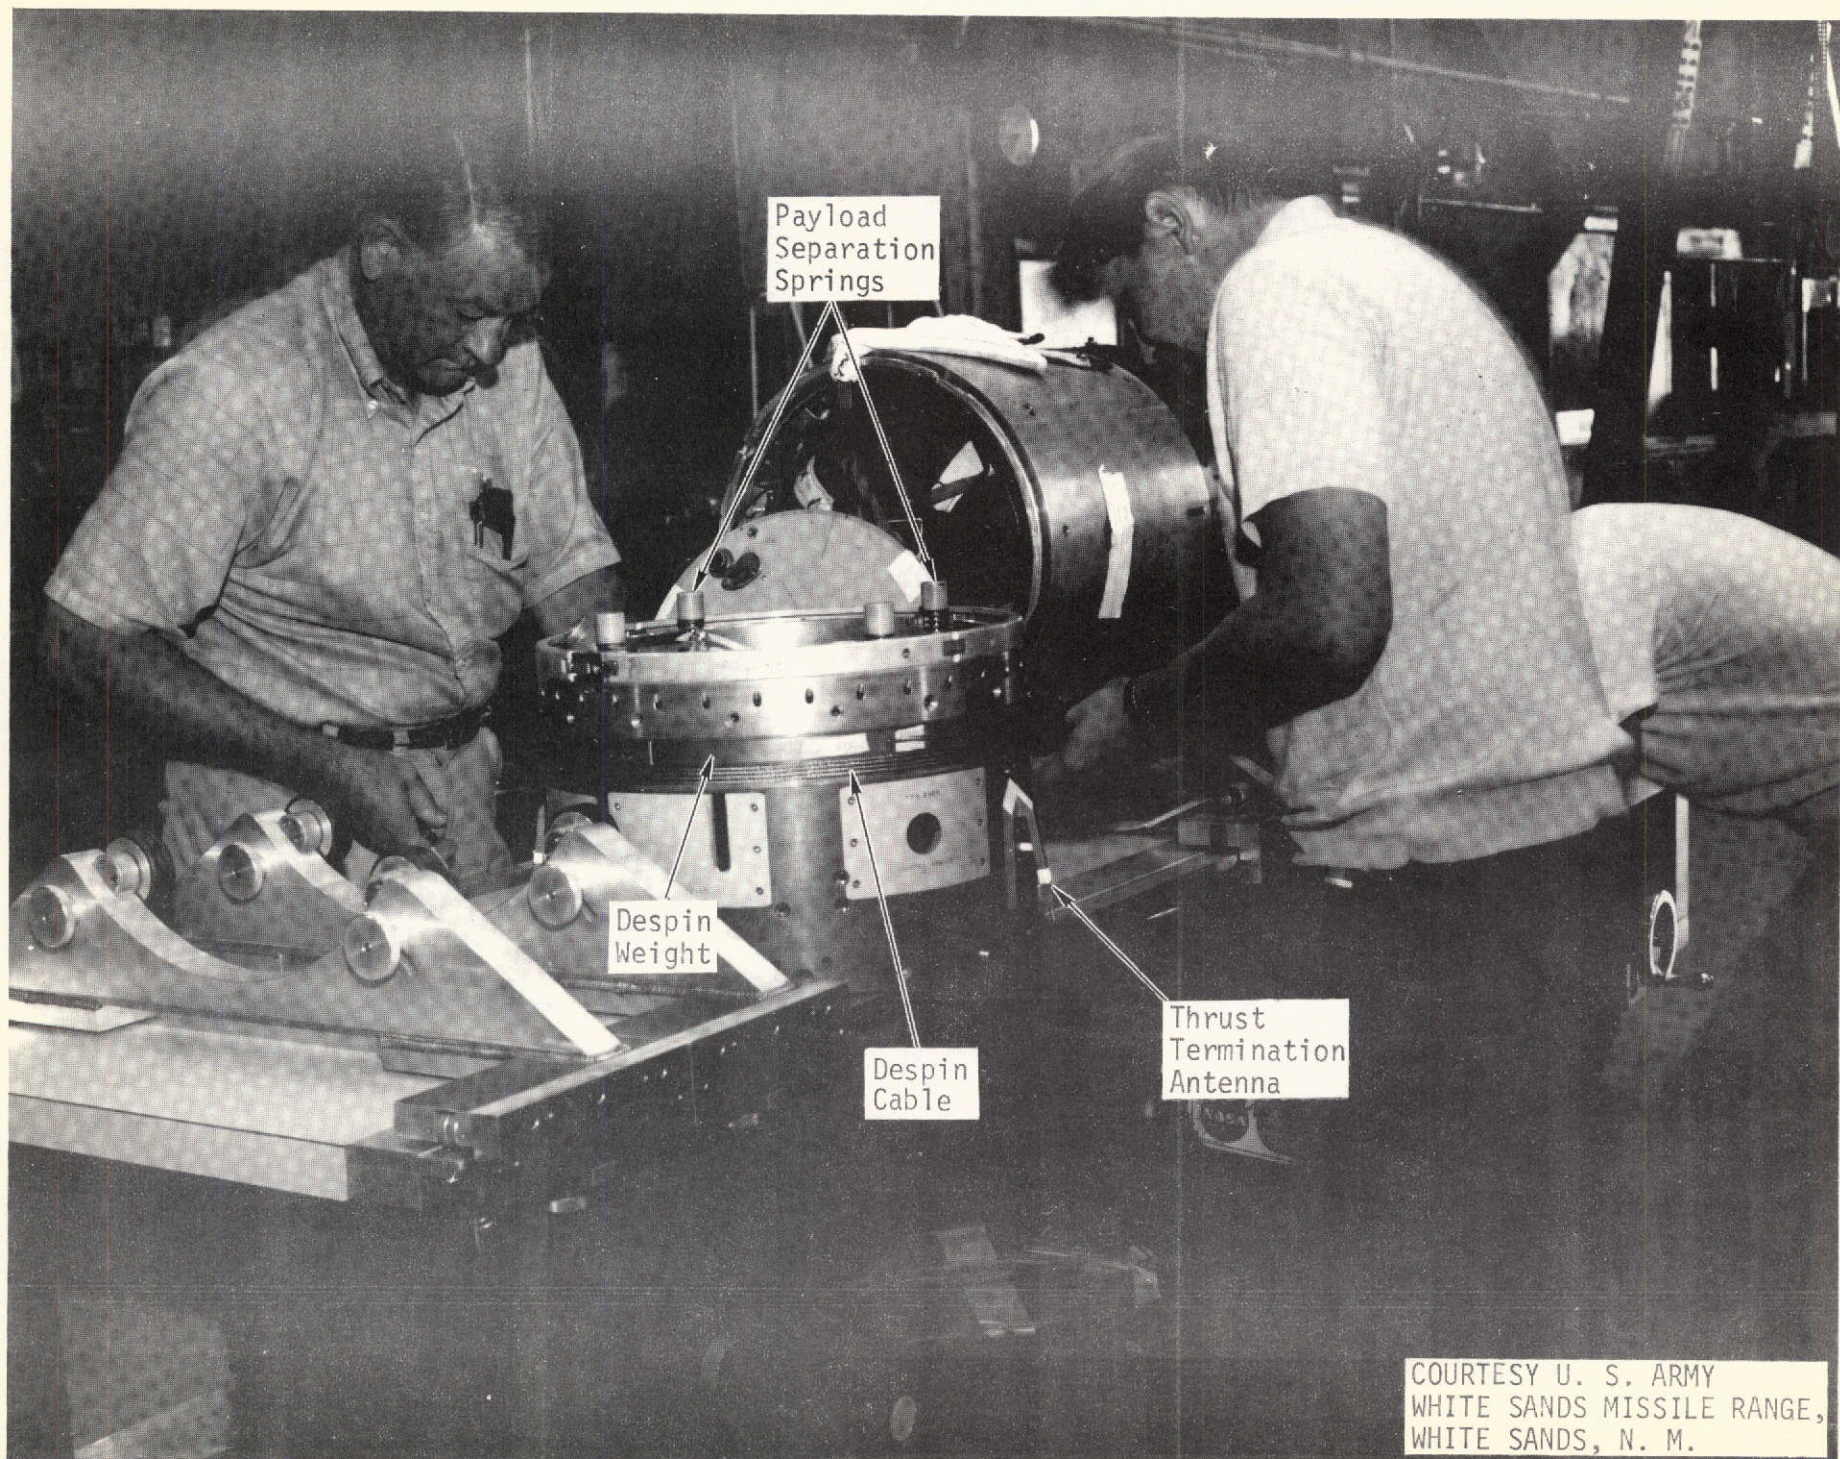
Figure 2-22. Typical CAIROC Igniter Housing.

approximately 1 second. The weights fit into cutouts in the Igniter Housing and the cables were wrapped around the housing in a circular groove. Prior to deployment the two weights were secured by a single cable which passed through the center of the housing. Release of the weights was achieved by severing the cable with a pyrotechnic cutter. Two cutters were supplied for redundancy. After the rocket and payload were despun, then mechanical timer signal initiated payload separation.

The thrust termination unit consisted of two flexible linear shaped charges which were bonded into a moulded polyurethane foam ring. One charge was positioned to sever the Igniter Housing wall and the other placed in a slightly offset position over the motor head end. This charge was designed to cut a hole in the head end thus neutralizing thrust as well as inducing a tumbling motion to the Motor. Since the shaped charges were located in the Igniter Housing, extensive damage to the Igniter Housing and the payload end attached to the Igniter Housing was expected if thrust termination was ever commanded. Such a situation occurred on CALROC flight 21.021 and will be discussed in the performance section of this report.
